Home Inspection Report

3778 Cabin Road, Reva, VA 22735

Inspection Date:

Monday August 29, 2016

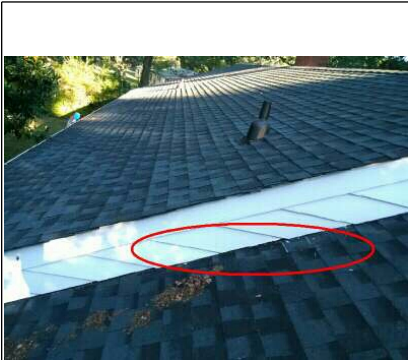
-It is recommended that wood siding stay two inches above roofline to prevent moisture wicking

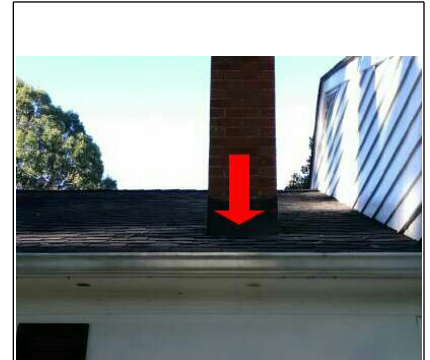
- The flashing of the chimney on the left side of house is raised above shingles recommend evaluation and Repairs by a qualified professional

Condition Poor Separated from chimney/roof

Comments - The flashing of the chimney on the left side of house is raised above shingles recommend evaluation and Repairs by a qualified professional

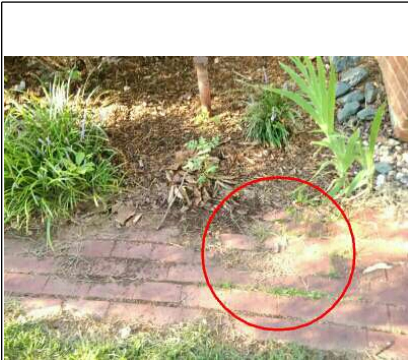
- The front sidewalk has settled and is possibly causing a trip Hazard recommend repair

Condition Marginal Trip hazard Settling cracks

Comments - The front sidewalk has settled and is possibly causing a trip Hazard recommend repair

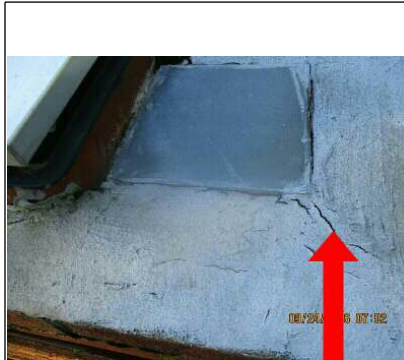
-The chimney crown on right side of house is cracked . I recommend evaluation and repair by a qualified mason

Evidence of Cracked chimney cap

Comments -The chimney crown on right side of house is cracked . I recommend evaluation and repair by a qualified mason

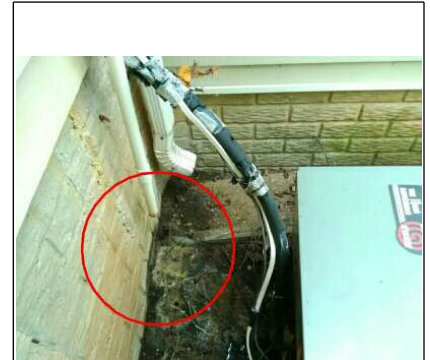
-I recommend an extension on the downspout on the back right of house to ensure proper drainage

Extension needed East

Comments -I recommend an extension on the downspout on the back right of house to ensure proper drainage
